ARIZONA DEPARTMENT OF ENVIRONMENTAL QUALITY

Air Quality Field Report

Company Name: Kirkland Mining Company RP: 86532	Inspection Report No.: 290045
Place Name: Kirkland Mining Company Lower Quarry Place ID No.: 162459	Inspector(s): Rob Verville
County: Yavapai	Arrival Date and Time: 9/29/2017 8:30 AM
Physical Location: 7825 S Iron Spring Rd., Skull Valley, AZ 86338	Reason for Inspection: <input type="checkbox"/> Complaint Complaint No.: <input checked="" type="checkbox"/> Routine Inspection (demonstration) <input type="checkbox"/> Follow-Up Original Inspection Report No.:
Mailing Address: 3737 Garden Ln., San Diego, CA 92106	
Coordinates (for new locations): Latitude: Deg.: Min.: Sec.: Longitude: Deg.: Min.: Sec.:	
Permit No.: 68023 ATO: 121348 Permit Expiration Date: 4/24/2022	Was Inspection Announced? <input checked="" type="checkbox"/> Yes <input type="checkbox"/> No ADEQ is observing a demonstration
Onsite Contact Person(s)/Title(s): Areta Zouvas, President Al Birch, Consultant	Operational Status: Operating

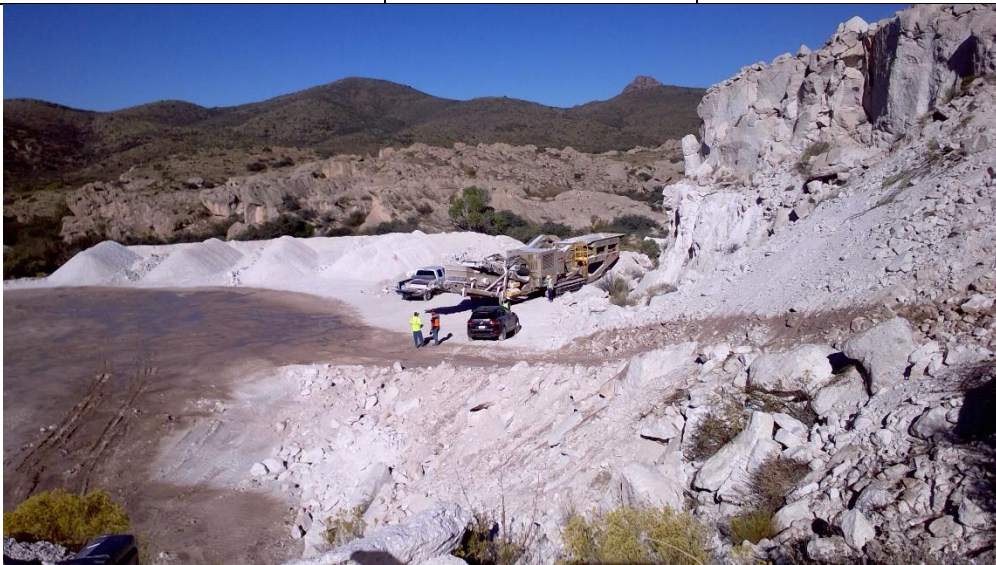
Photo No. 1	Date: 9/29/2017		
Direction Photo Taken: West			
Photo Description: Crusher and screening combined unit. Four test piles in background to left of machine. 2 piles are 1" minus 2 piles are 2" minus. Work pad and haul road wetted.

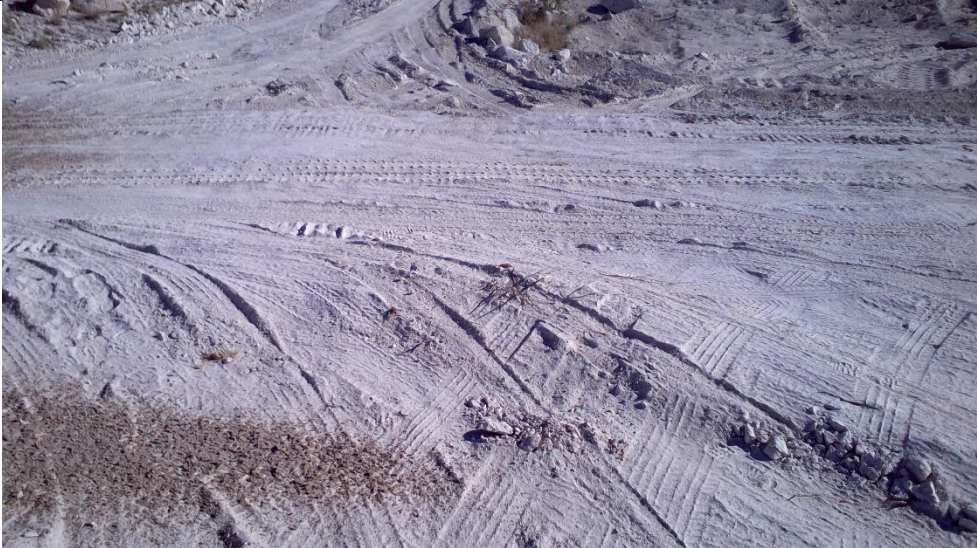
Photo No. 3	Date: 9/29/2017

Direction Photo Taken: Down		
Photo Description: Material on hauls road. Evidence of previous wetting. The material is loose, but the ADEQ inspector did not observe visible emissions from the light breeze. Some visible emission were created when passenger vehicles drove into the area. The visible emission from the passenger vehicle traffic was ephemeral.

Haul roads and equipment operating areas had evidence of wetting. An area on the upper haul road with an observation area overlooking the C&S unit had an accumulation of loose material with equipment and vehicle tracks pressed into it. During the demonstration, a light breeze blew and the ADEQ inspector did not observe any visible emissions from the haul roads or operating areas.

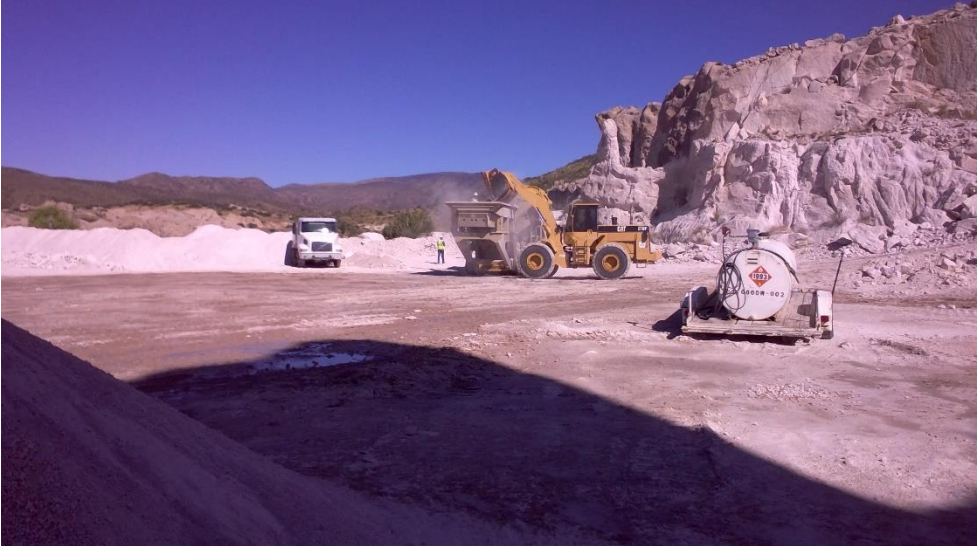
Photo No. 4	Date: 9/29/2017

Direction Photo Taken: North		
Photo Description: Photo taken as demonstration started. The front-end loader dumps into the feeder for the C&S plant. Visible emissions are present. Evidence of wetting on ground. One area has pooled water.

Visible emissions were present when the front-end loader dumped into the feeder. The feeder is a compartment that contains material as it is supplied to the crusher. Feeders are not included in the listed pieces of equipment in Permit Condition - Attachment "C" Part I.A.1.

- The general permit requires the source to have someone on-site or on-call certified in EPA Method 9 (smoke school). It may be best to have someone Method 9 onsite when mining and processing is occurring to be able quickly identify if a visible emission or opacity issue needs to be addressed.
- Installing a water mister or fogger system at the feeder may provide additional knockdown of any visible emissions created when the front-end loader is dumping into the feeder.

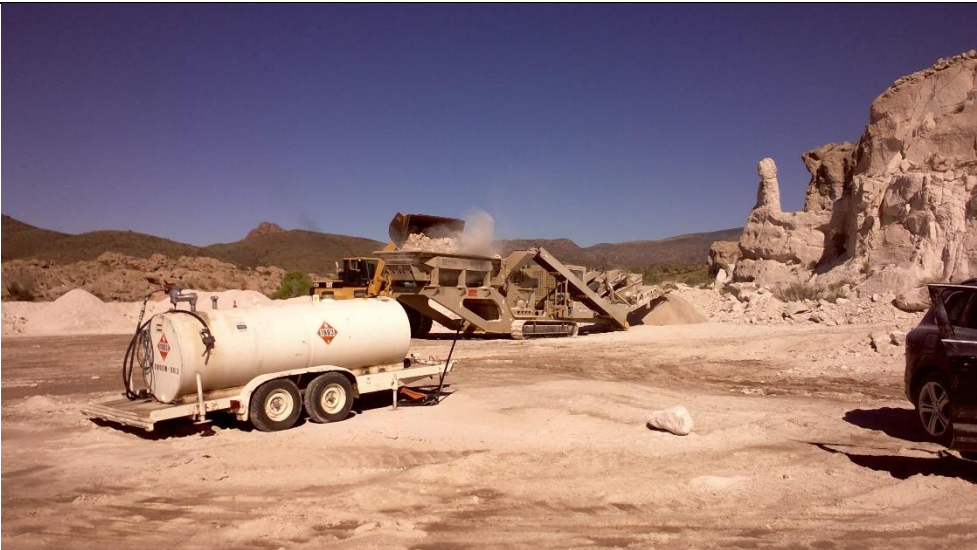
Photo No. 5	Date: 9/29/2017	 
Direction Photo Taken: North		
Photo Description: Front-end loader dumping into C&S plant feeder. Visible emissions created when front-end loader dumping into feeder.

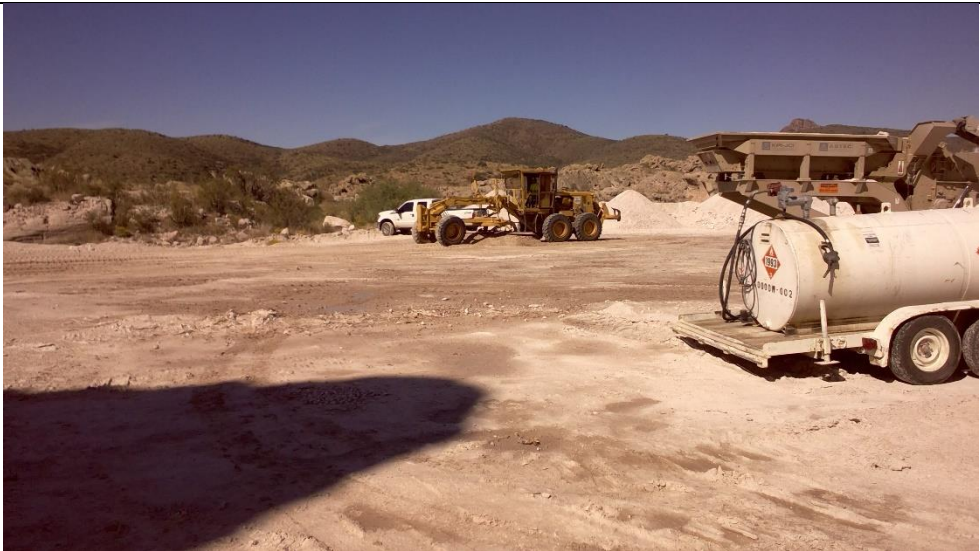
Photo No. 7	Date: 9/29/2017

Direction Photo Taken: Northwest		
Photo Description: Motor grader operating. No visible emissions created when operating.

The first run of the demonstration was crushing and screening the material to a 1" minus, then the screens were changed and a 2" minus material was processed. Between the runs, a motor grader smoothed the path between the stockpile and the C&S plant. No visible emission were created by the grading.

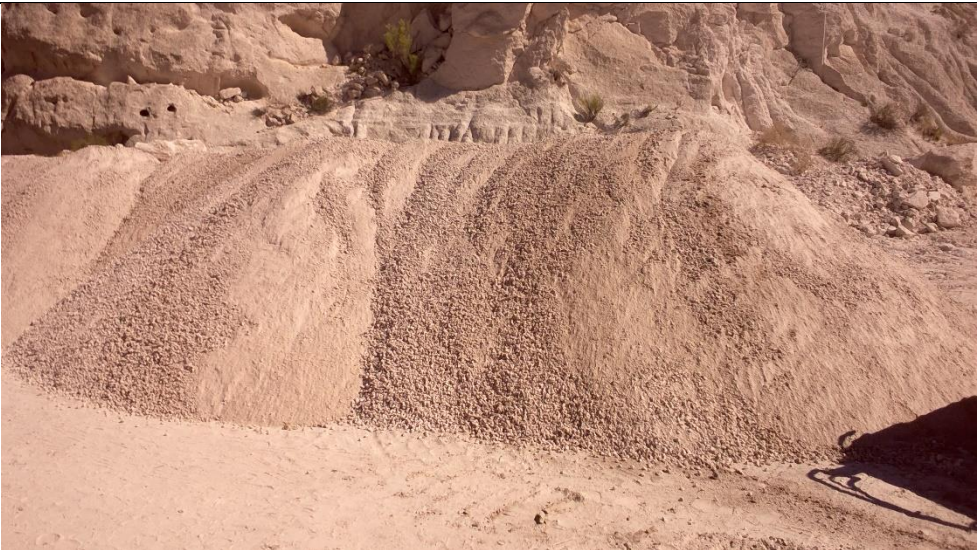
Photo No. 8	Date: 9/29/2017

Direction Photo Taken: North		
Photo Description: Material being produced during the demonstration.

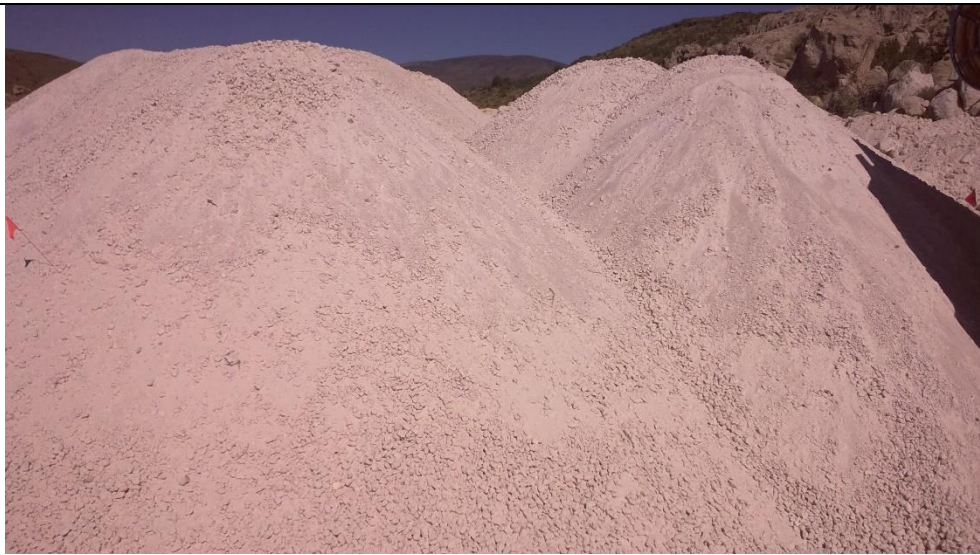
Photo No. 9	Date: 9/29/2017

Direction Photo Taken: West		
Photo Description: Store pile of 1" minus material produced earlier in the week.

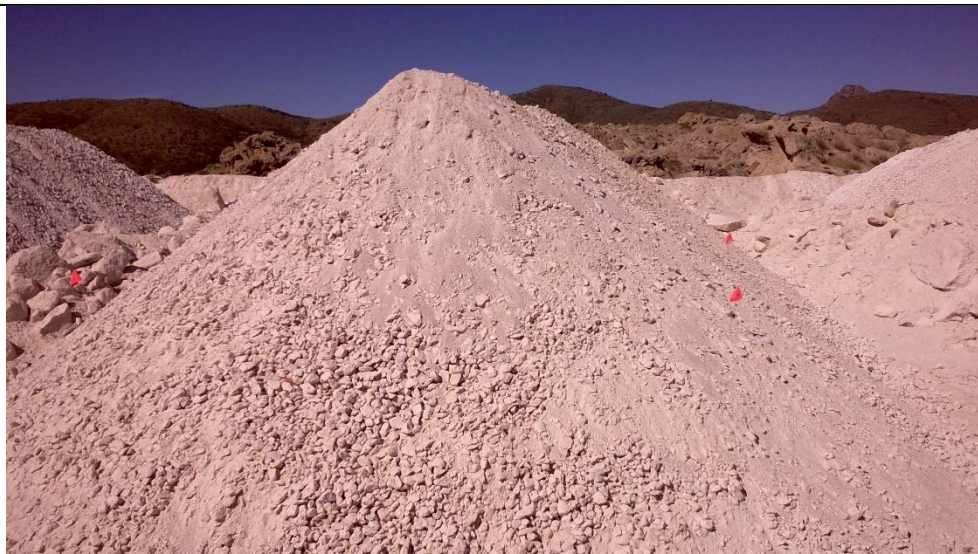
Photo No. 10	Date: 9/29/2017

Direction Photo Taken: West		
Photo Description: Store pile of 2" minus material produced earlier in the week.

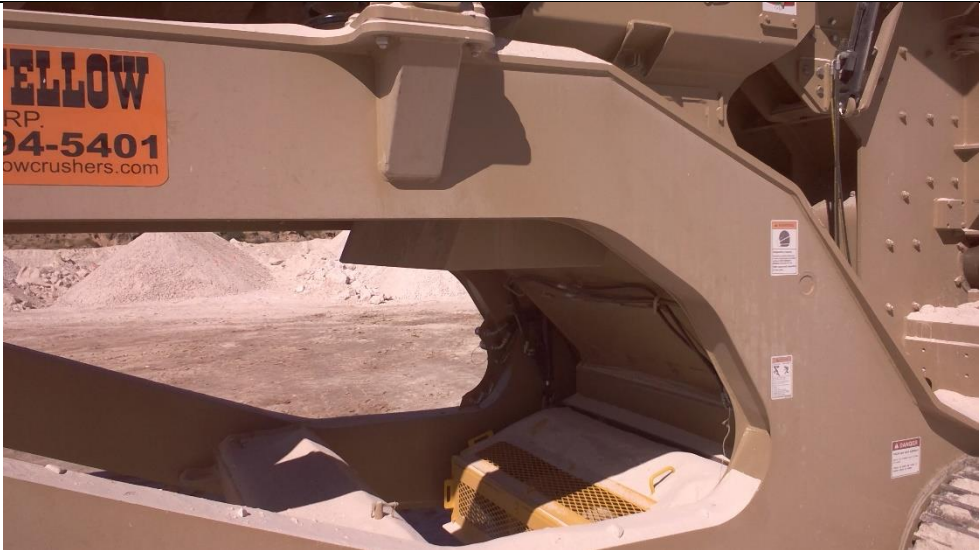
Photo No. 11	Date: 9/29/2017

Direction Photo Taken: Northwest		
Photo Description: Frame on C&S plant below the feeder. An accumulation of material is built up on the frame.

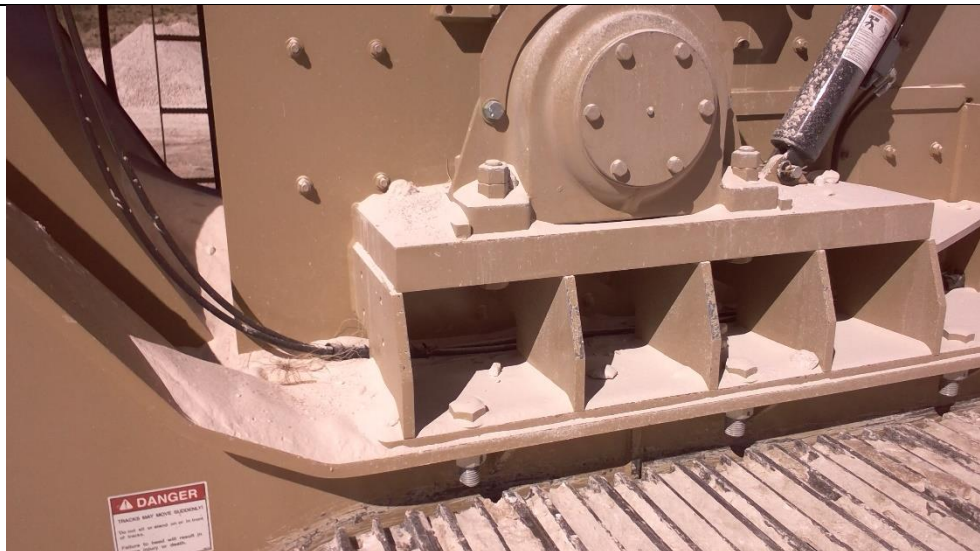
Photo No. 12	Date: 9/29/2017
Direction Photo Taken: Northwest	
Photo Description: Frame on C&S plant below the feeder. An accumulation of material is built up on the frame.

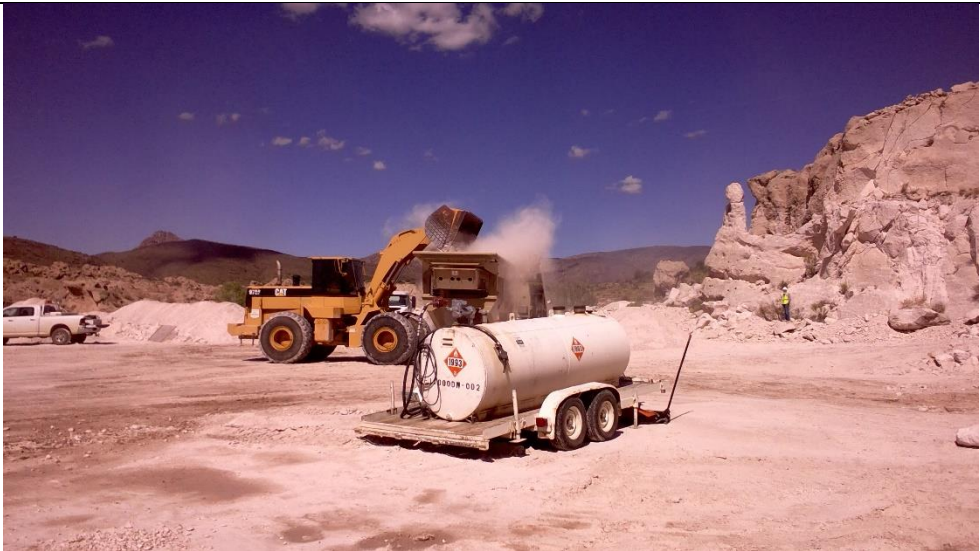
Photo No. 13	Date: 9/29/2017

Direction Photo Taken: North		
Photo Description: Front-end loader dumping into feeder of C&S plant.

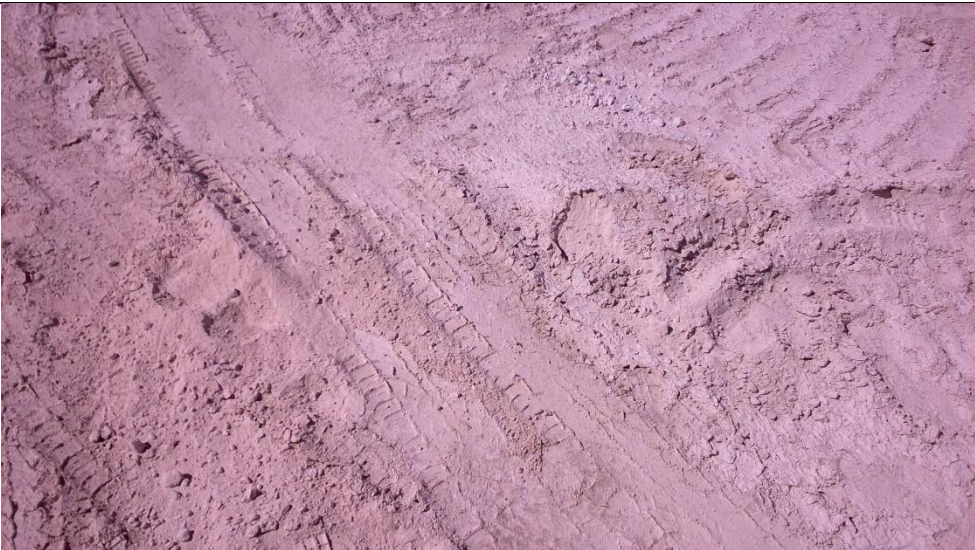
Photo No. 14	Date: 9/29/2017

Direction Photo Taken: Down		
Photo Description: Evidence of crust on soil in areas adjacent to C&S plant. The ADEQ inspector used his foot to break the crust to verify its integrity.

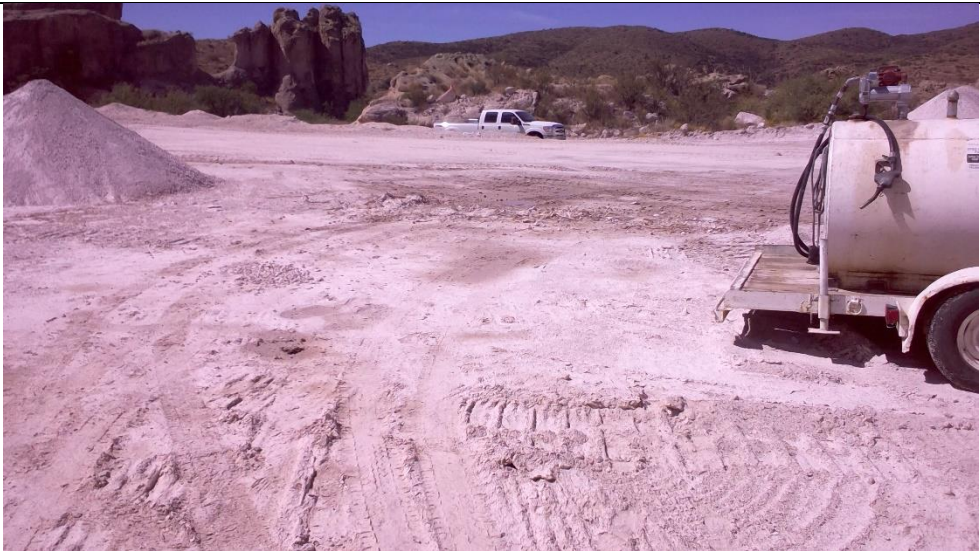
Photo No. 15	Date: 9/29/2017

Direction Photo Taken: West		
Photo Description: After several hours the wetting was still evident.

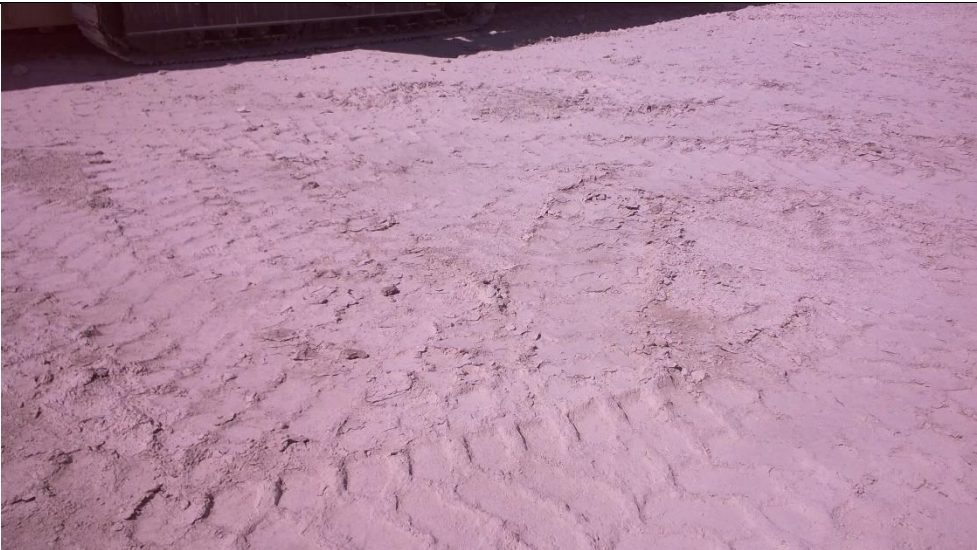
Photo No. 18	Date: 9/29/2017

Direction Photo Taken: Northwest		
Photo Description: The material on the ground retains moisture. Equipment tracks are evident.

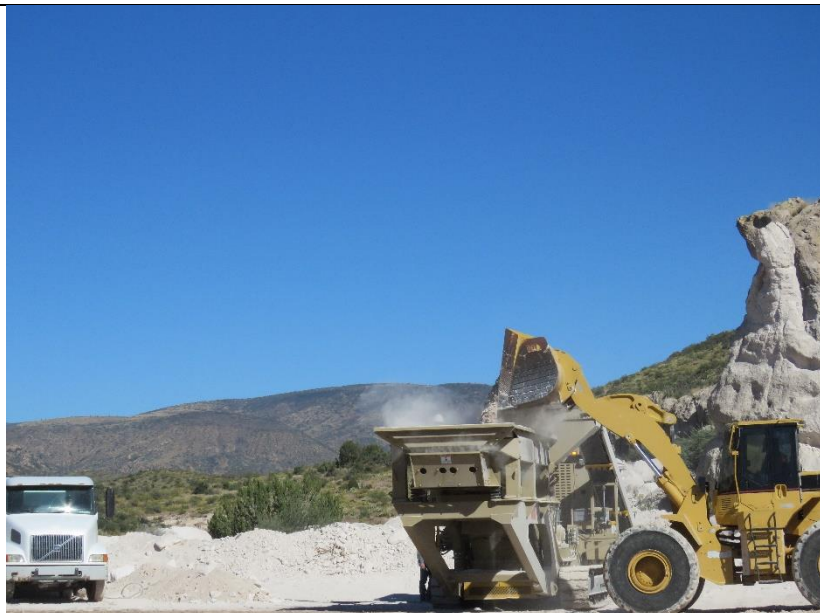
Photo No. 20	Date: 9/29/2017

Direction Photo Taken: North		
Photo Description: The following pictures are associated with the DOCS observation. The pictures were randomly culled from the DOCS pictures. See DOCS results for 6 minute opacity readings. Plant is operating.

DOCSII digital opacity observations were collected during the demonstration while the C&S plant was operating. The DOCS observation results have been completed and are attached to this report.

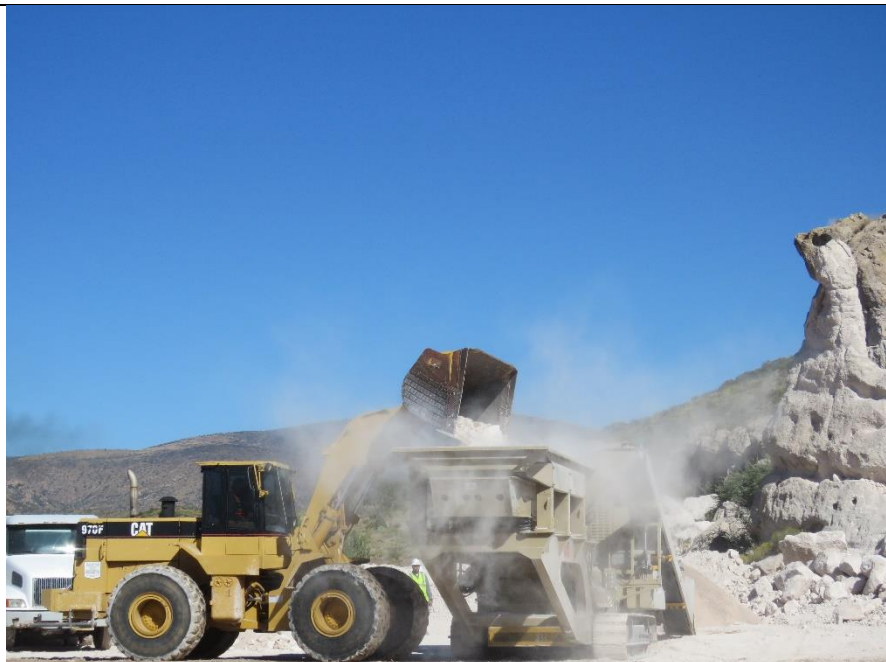
Photo No. 22	Date: 9/29/2017

Direction Photo Taken: North		
Photo Description: The following pictures are associated with the DOCS observation. The pictures were randomly culled from the DOCS pictures. Plant is operating.

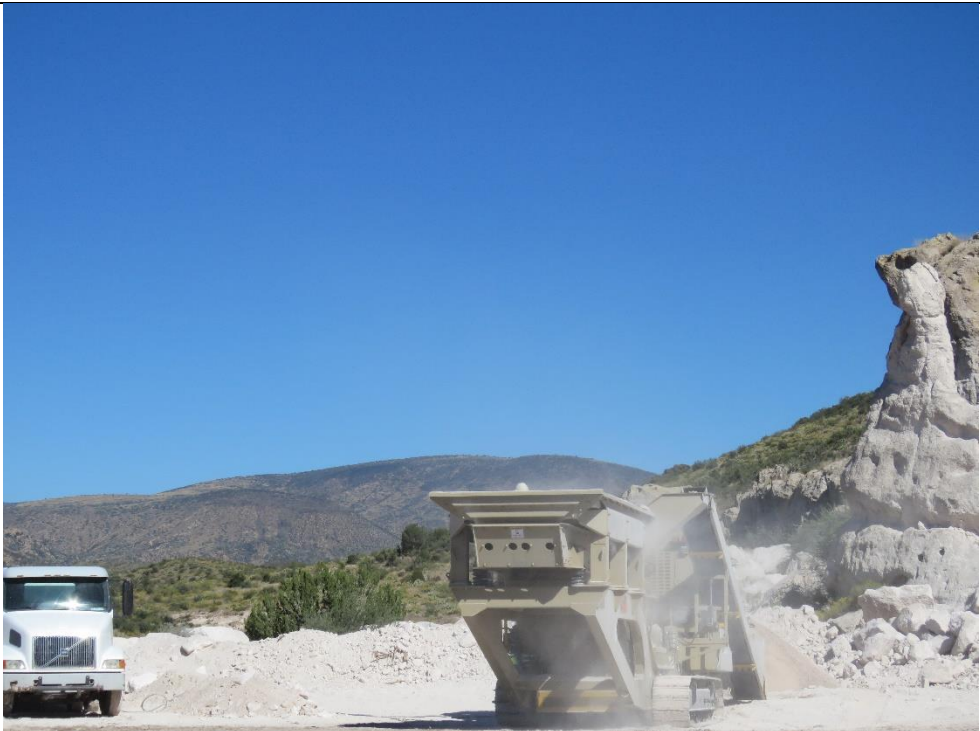
Photo No. 23	Date: 9/29/2017

Direction Photo Taken: Northwest		
Photo Description: The following pictures are associated with the DOCS observation. The pictures were randomly culled from the DOCS pictures. Plant is operating.

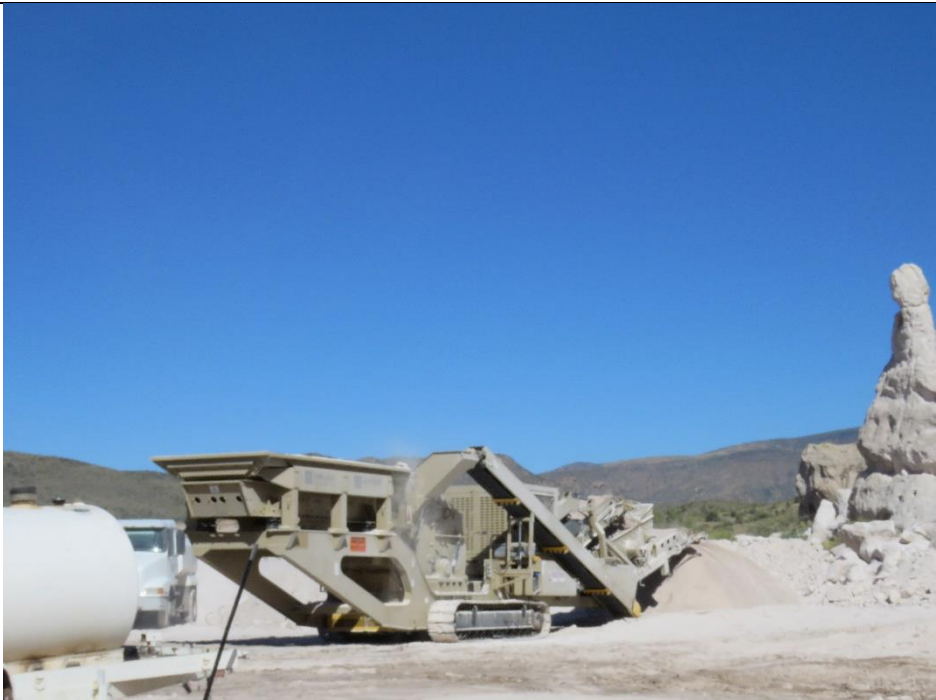
Photo No. 24	Date: 9/29/2017

Direction Photo Taken: Northwest		
Photo Description: The following pictures are associated with the DOCS observation. The pictures were randomly culled from the DOCS pictures. Plant is operating.

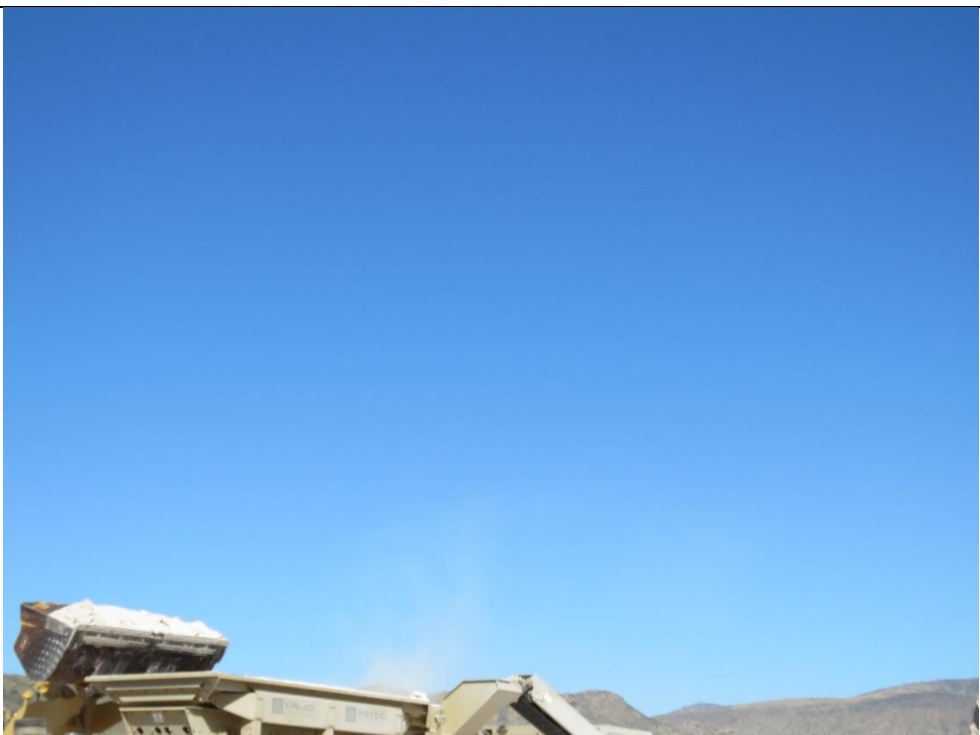
Photo No. 25	Date: 9/29/2017

Direction Photo Taken: Northwest		
Photo Description: The following pictures are associated with the DOCS observation. The pictures were randomly culled from the DOCS pictures. Plant is operating.

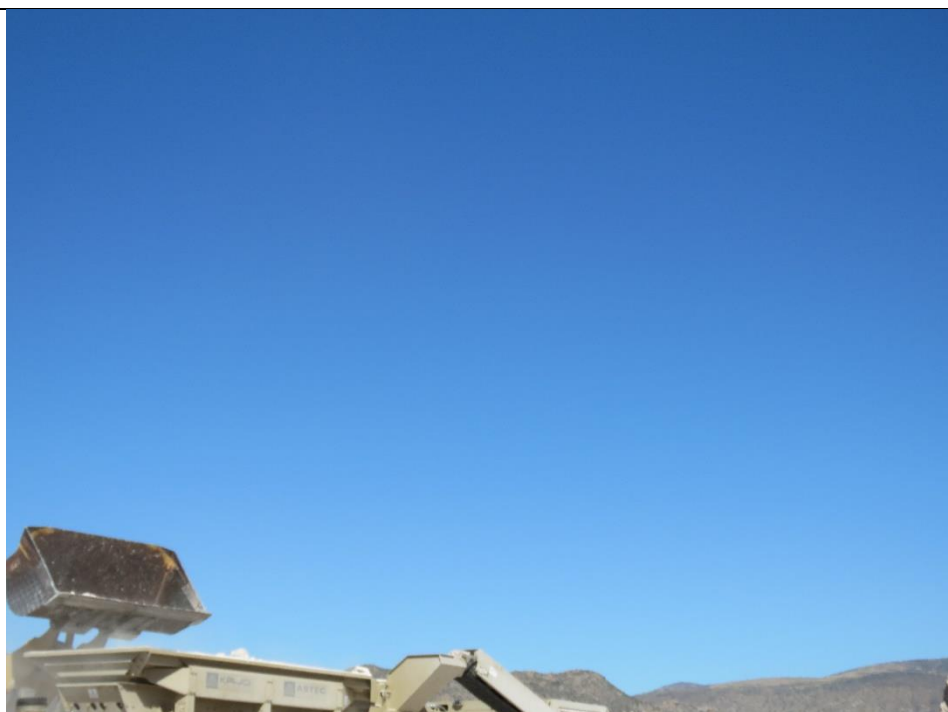
Photo No. 26	Date: 9/29/2017

Direction Photo Taken: Northwest		
Photo Description: The following pictures are associated with the DOCS observation. The pictures were randomly culled from the DOCS pictures. Plant is operating.

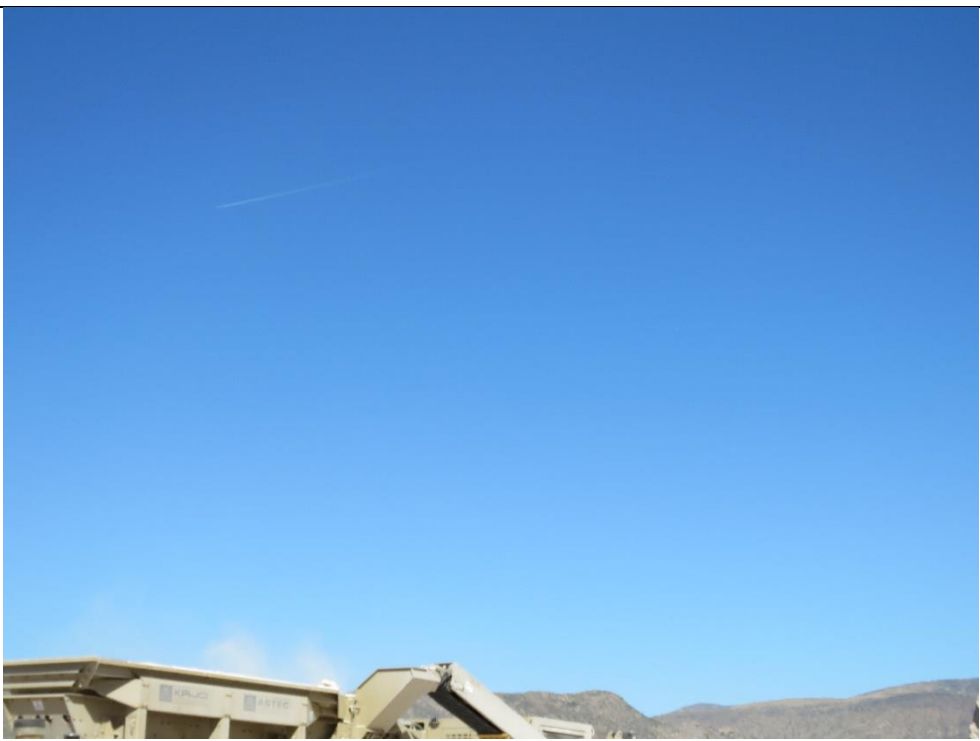
Photo No. 27	Date: 9/29/2017

Direction Photo Taken: North		
Photo Description: The following pictures are associated with the DOCS observation. The pictures were randomly culled from the DOCS pictures. Plant is operating.

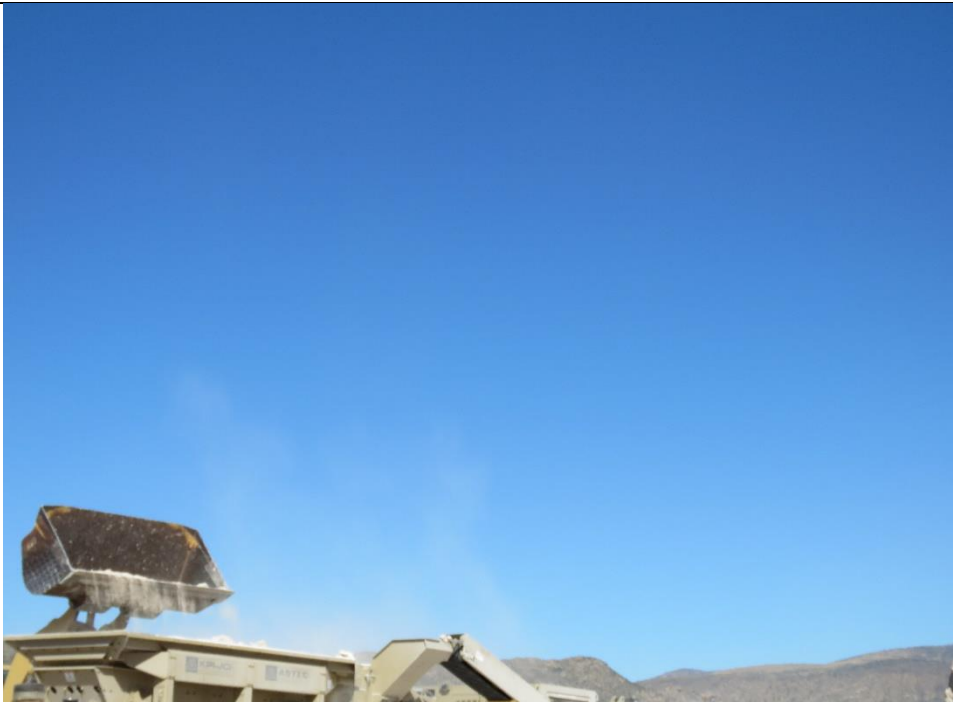
Photo No. 28	Date: 9/29/2017

Direction Photo Taken: North		
Photo Description: The following pictures are associated with the DOCS observation. The pictures were randomly culled from the DOCS pictures. Plant is operating.

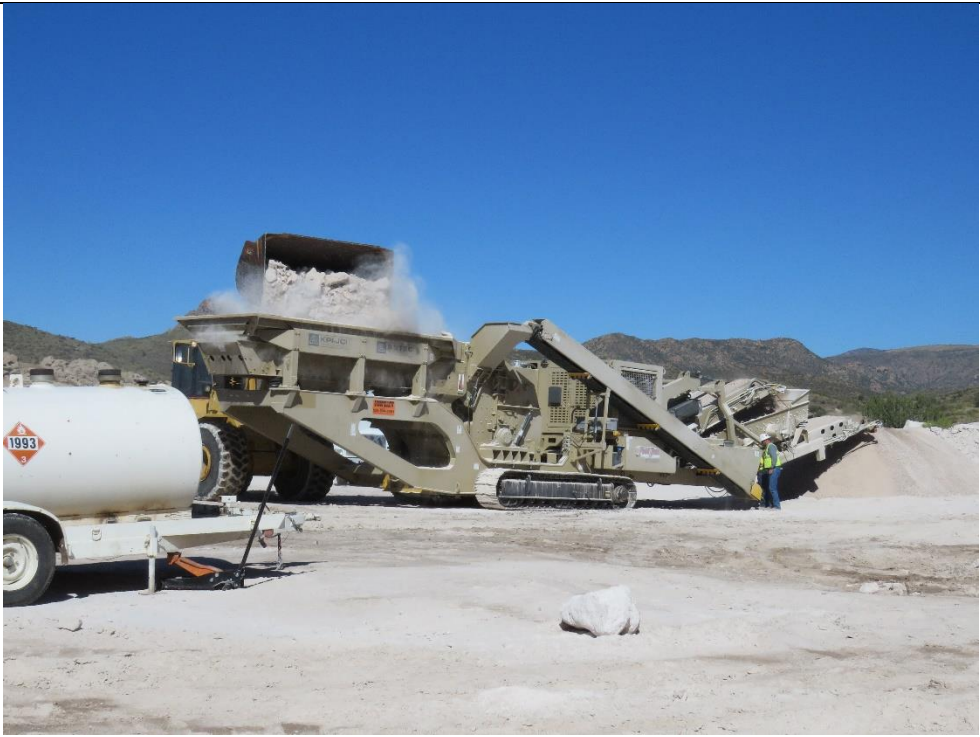
Photo No. 29	Date: 9/29/2017

Direction Photo Taken: North		
Photo Description: The following pictures are associated with the DOCS observation. The pictures were randomly culled from the DOCS pictures. Plant is operating.

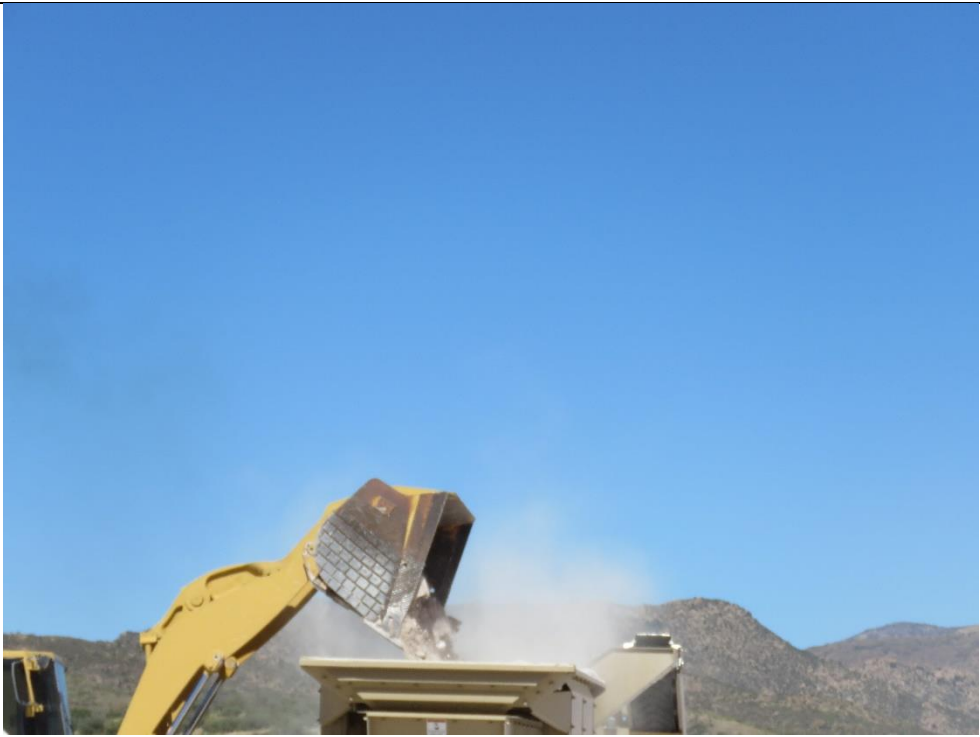
Photo No. 31	Date: 9/29/2017

Photo No. 30	Date: 9/29/2017	 
Direction Photo Taken: North		
Photo Description: The following pictures are associated with the DOCS observation. The pictures were randomly culled from the DOCS pictures. Plant is operating.

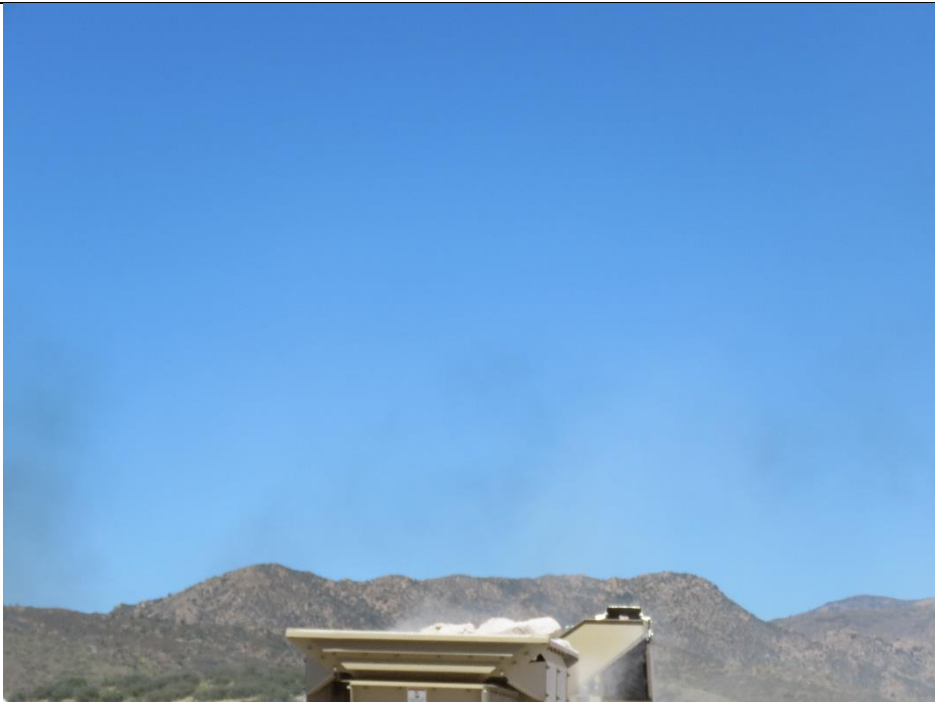
Photo No. 32	Date: 9/29/2017

Direction Photo Taken: North		
Photo Description: The following pictures are associated with the DOCS observation. The pictures were randomly culled from the DOCS pictures. Plant is operating.

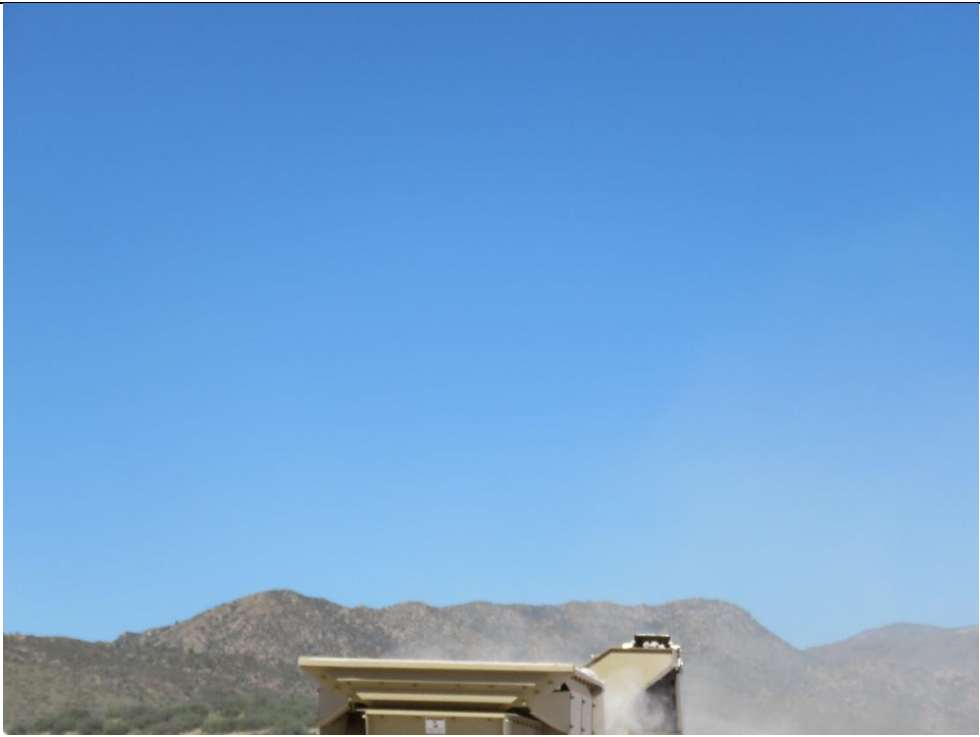
Photo No. 33	Date: 9/29/2017

Direction Photo Taken: North		
Photo Description: The following pictures are associated with the DOCS observation. The pictures were randomly culled from the DOCS pictures. Plant is operating.

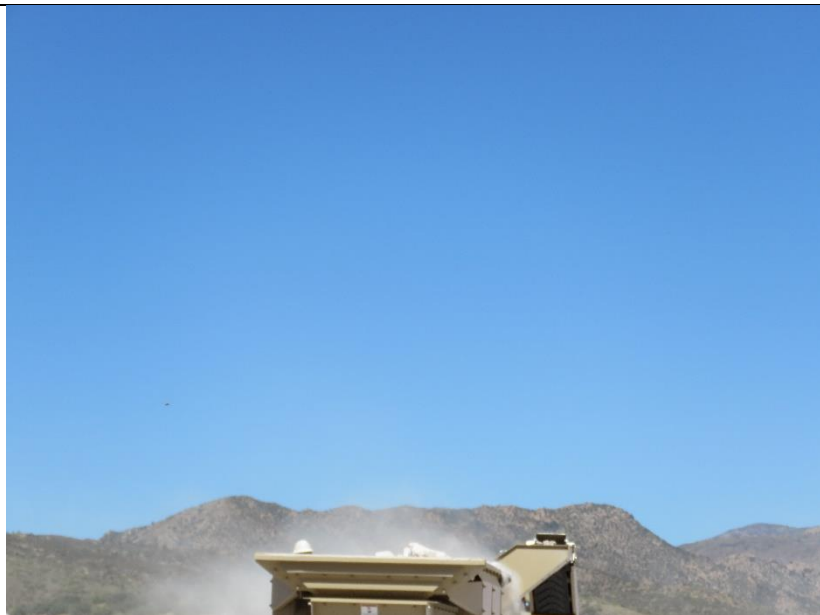
Photo No. 34	Date: 9/29/2017

Direction Photo Taken: North		
Photo Description: The following pictures are associated with the DOCS observation. The pictures were randomly culled from the DOCS pictures. Plant is operating.

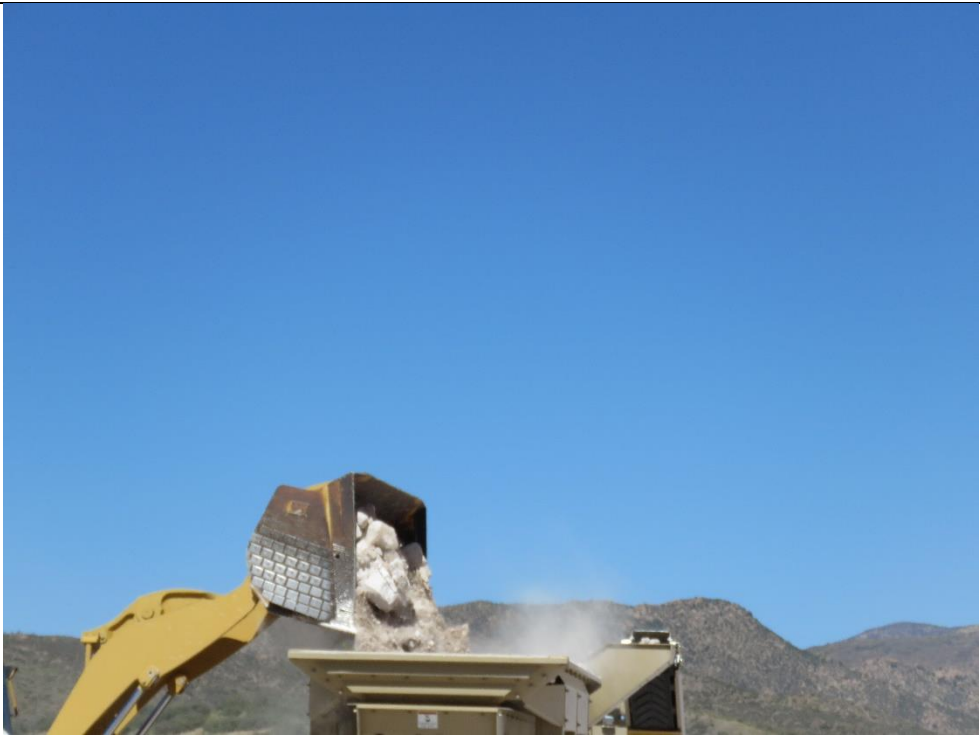
Photo No. 35	Date: 9/29/2017

Direction Photo Taken: North		
Photo Description: The following pictures are associated with the DOCS observation. The pictures were randomly culled from the DOCS pictures. Plant is operating.

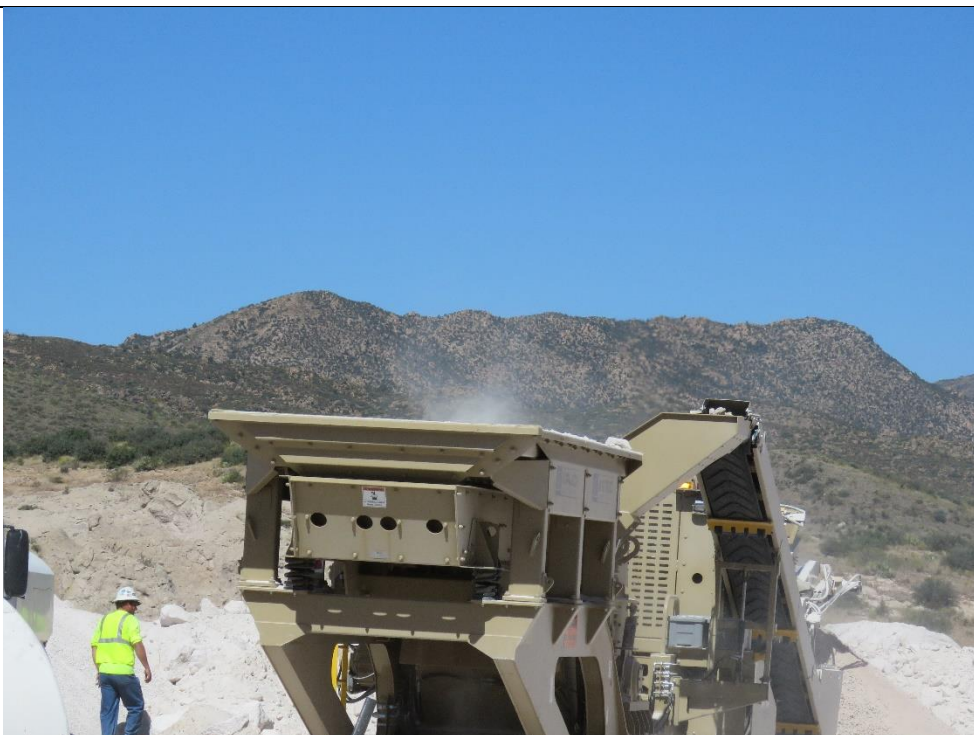
Photo No. 37	Date: 9/29/2017

Photo No. 36	Date: 9/29/2017	 
Direction Photo Taken: North		
Photo Description: The following pictures are associated with the DOCS observation. The pictures were randomly culled from the DOCS pictures. Plant is operating.

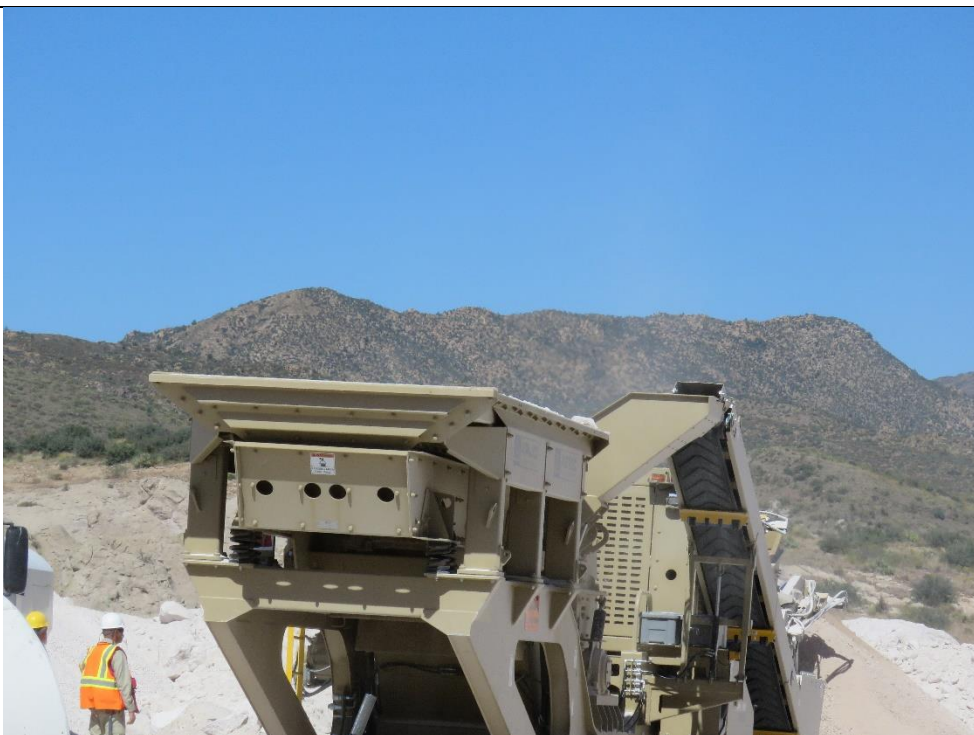
Photo No. 39	Date: 9/29/2017

Photo No. 38	Date: 9/29/2017	 
Direction Photo Taken: North		
Photo Description: The following pictures are associated with the DOCS observation. The pictures were randomly culled from the DOCS pictures. Plant is operating.

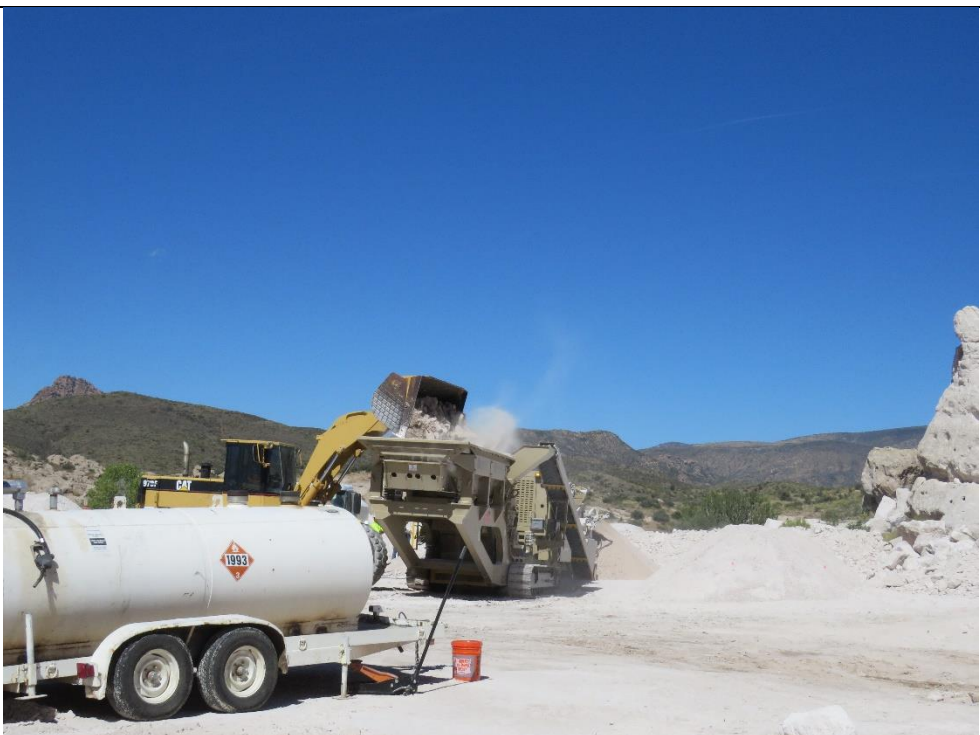
Photo No. 41	Date: 9/29/2017

Photo No. 40	Date: 9/29/2017	 
Direction Photo Taken: North		
Photo Description: The following pictures are associated with the DOCS observation. The pictures were randomly culled from the DOCS pictures. Plant is operating.

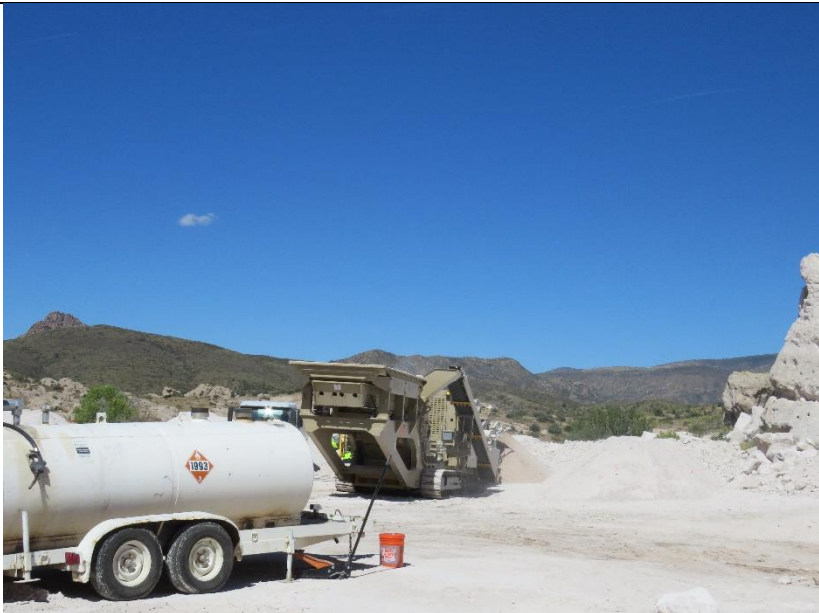
Photo No. 42	Date: 9/29/2017

Direction Photo Taken: Northwest		
Photo Description: The following pictures are associated with the DOCS observation. The pictures were randomly culled from the DOCS pictures. Plant is operating.

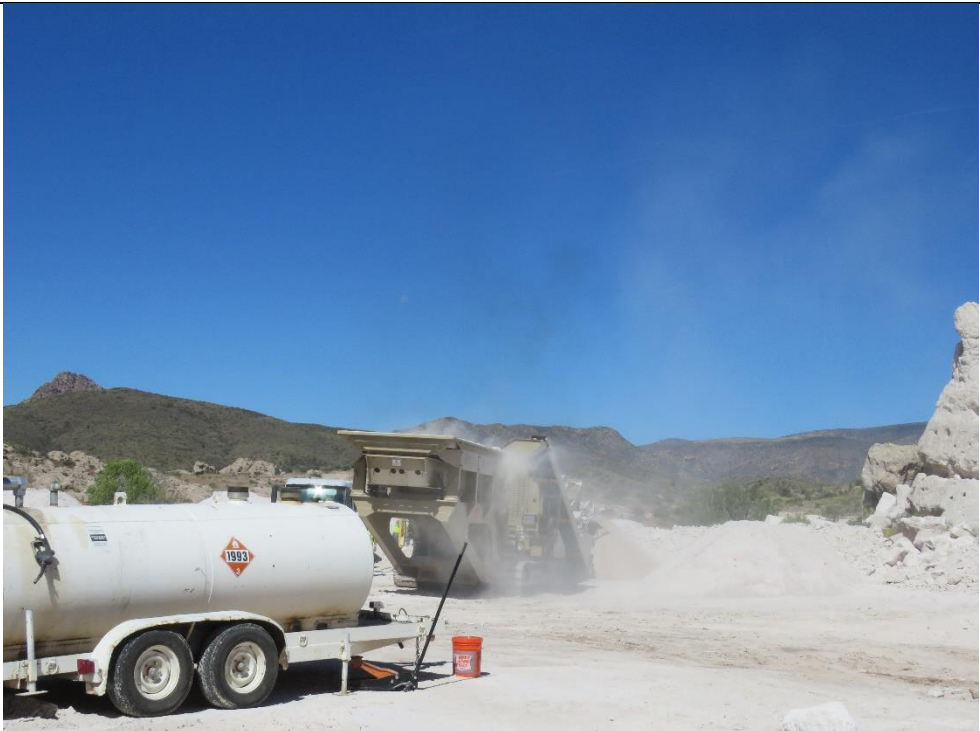
Photo No. 43	Date: 9/29/2017

Direction Photo Taken: Northwest		
Photo Description: The following pictures are associated with the DOCS observation. The pictures were randomly culled from the DOCS pictures. Plant is operating.
