ARIZONA DEPARTMENT OF ENVIRONMENTAL QUALITY

Air Quality Field Report

Company Name: Kirkland Mining Company RP: 86532	Inspection Report No.: 290045
Place Name: Kirkland Mining Company Lower Quarry Place ID No.: 162459	Inspector(s): Rob Verville
County: Yavapai	Arrival Date and Time: 9/29/2017 8:30 AM
Physical Location: 7825 S Iron Spring Rd., Skull Valley, AZ 86338	Reason for Inspection: <input type="checkbox"/> Complaint Complaint No.: <input checked="" type="checkbox"/> Routine Inspection (demonstration) <input type="checkbox"/> Follow-Up Original Inspection Report No.:
Mailing Address: 3737 Garden Ln., San Diego, CA 92106	
Coordinates (for new locations): Latitude: Deg.: Min.: Sec.: Longitude: Deg.: Min.: Sec.:	
Permit No.: 68023 ATO: 121348 Permit Expiration Date: 4/24/2022	Was Inspection Announced? <input checked="" type="checkbox"/> Yes <input type="checkbox"/> No ADEQ is observing a demonstration
Onsite Contact Person(s)/Title(s): Areta Zouvas, President Al Birch, Consultant	Operational Status: Operating

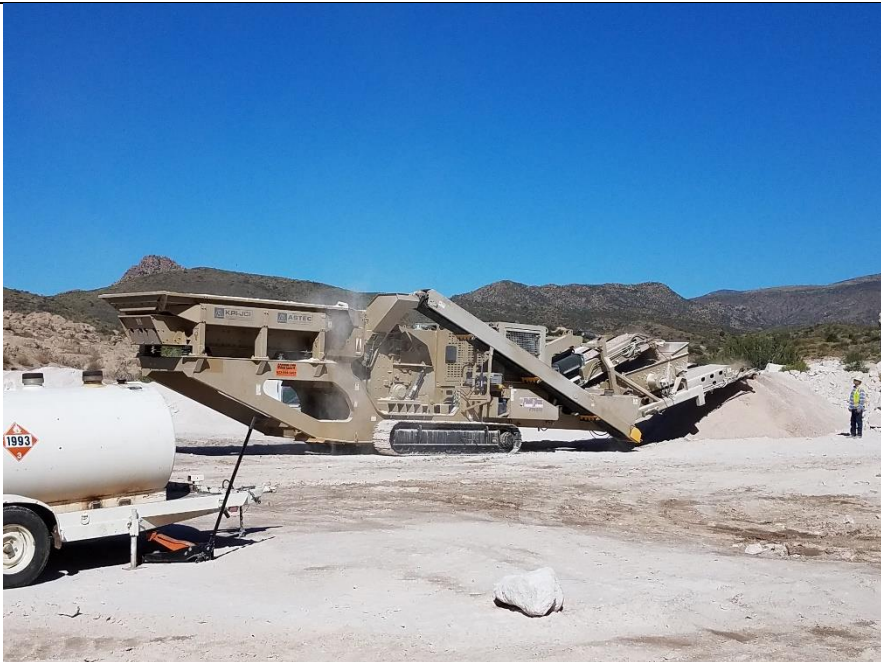
Photo No. 44	Date: 9/29/2017

Direction Photo Taken: North		
Photo Description: The following pictures are associated with the DOCS observation. The pictures were randomly culled from the DOCS pictures. Plant is operating.
